# Manhole Inspection Summary

Manhole # **S17G\_\_006MH**

**Location** Address: **4 WARWICK-WHEELER**

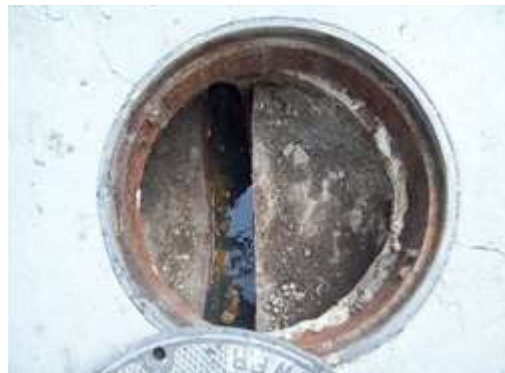
Top View

**Frame** Offset: **2** (in.) Condition: ☒ Sound ☐ Cracked ☐ Leaks

frame offset

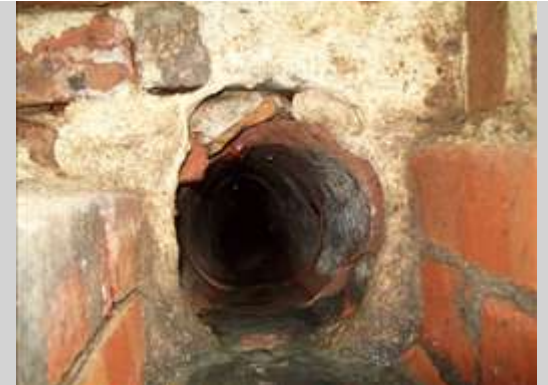
12 O'Clock Outflow

8 in. Circular Gravity Sewer  
Pipe Out @ 12 O'Clock

Pipe Height: **7.2** (in.) Rod and Bar (Angled)  
Pipe Material: **Clay** ☐ Pipe Lined  
Invert Depth: **2.94** (ft.) Flow Characteristics: **Slow**  
Deposits: ☒ None ☐ Mud ☐ Sludge ☐ **Debris** ☐ Grease  
Silt Depth: (in.) Deposits Extent:  
Infiltration: **None** Pipe Seal Cond: **Sound**

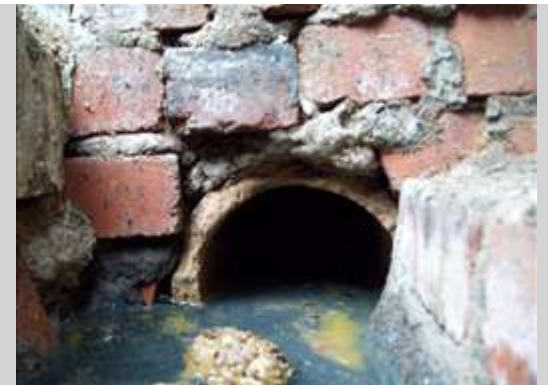
7 O'Clock Inflow

6 in. Circular Gravity Sewer  
Pipe In @ 7 O'Clock

Pipe Height: **6** (in.) Rod and Bar (Angled)  
Pipe Material: **Clay** ☐ Pipe Lined  
Invert Depth: **2.82** (ft.) Flow Characteristics: **Slow**  
Deposits: ☐ None ☐ Mud ☐ Sludge ☒ **Debris** ☐ Grease  
Silt Depth: **4** (in.) Deposits Extent: **Heavy**  
Infiltration: **None** Pipe Seal Cond: **Sound**
